# HTC SUPERFLOOR™ CONCRETE POLISHING

**Z-MILAN '92 Kft.**

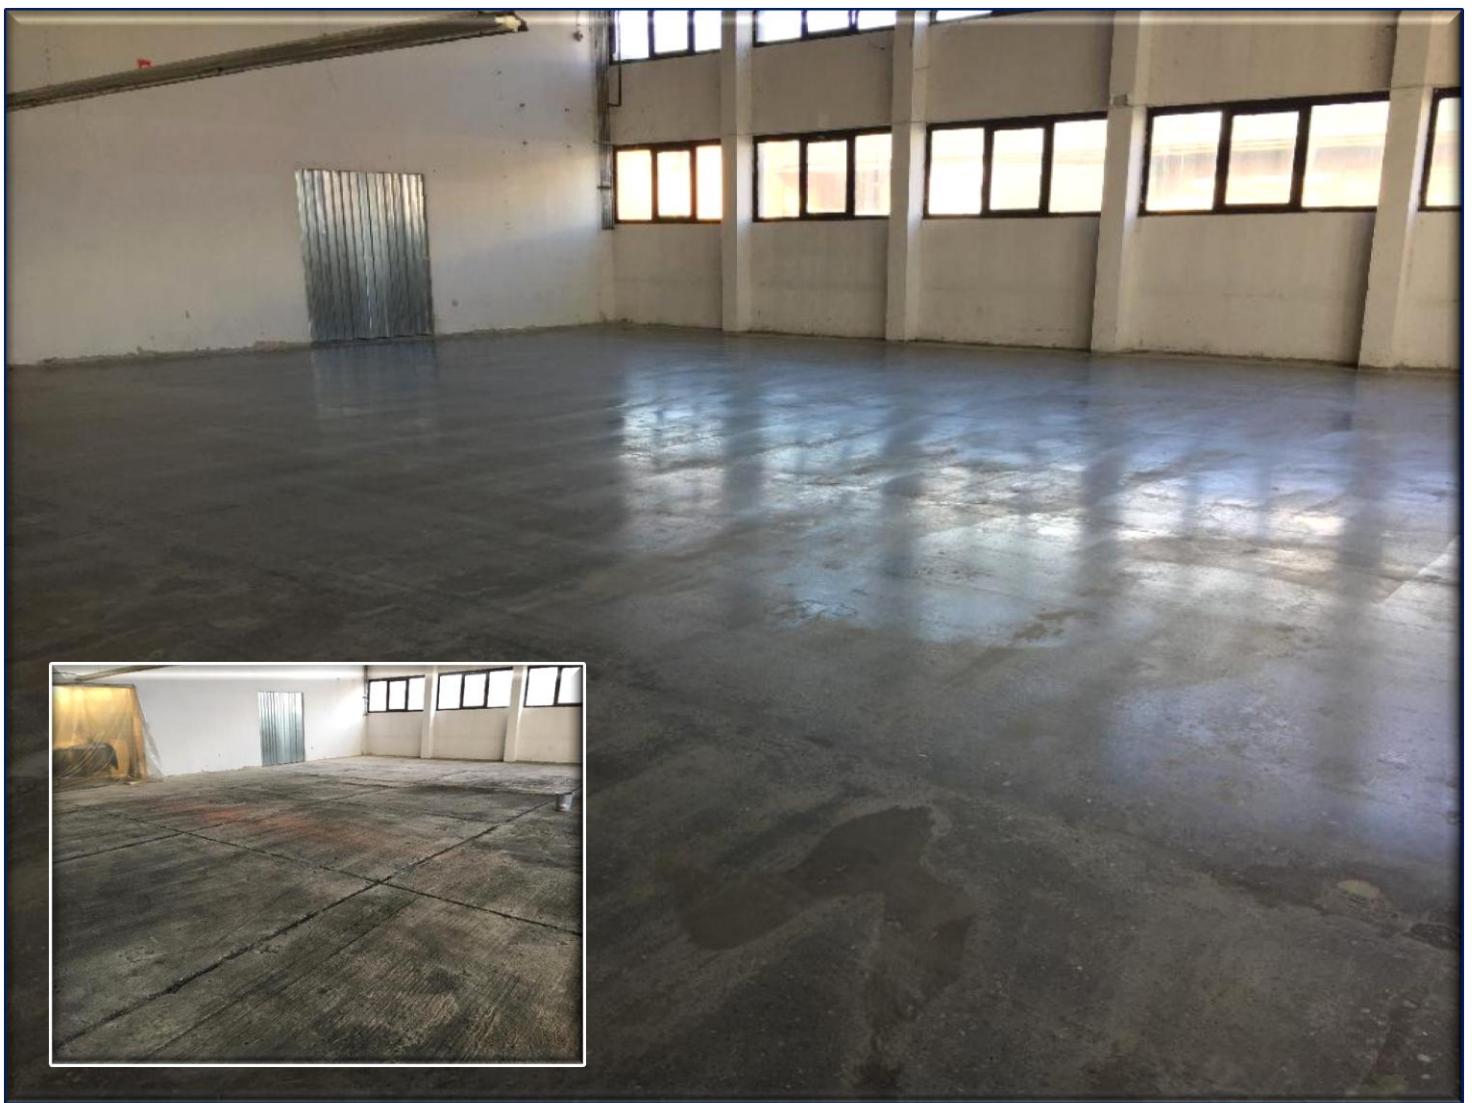
*Perfectly smooth, cost-effective, cleanable, and anti-slip surface executed with much repair.*
